RETAINING  
WALLS

COMMERCIAL  
DETAILS

**KORDON**<sup>®</sup>  
**TERMITE BARRIER**

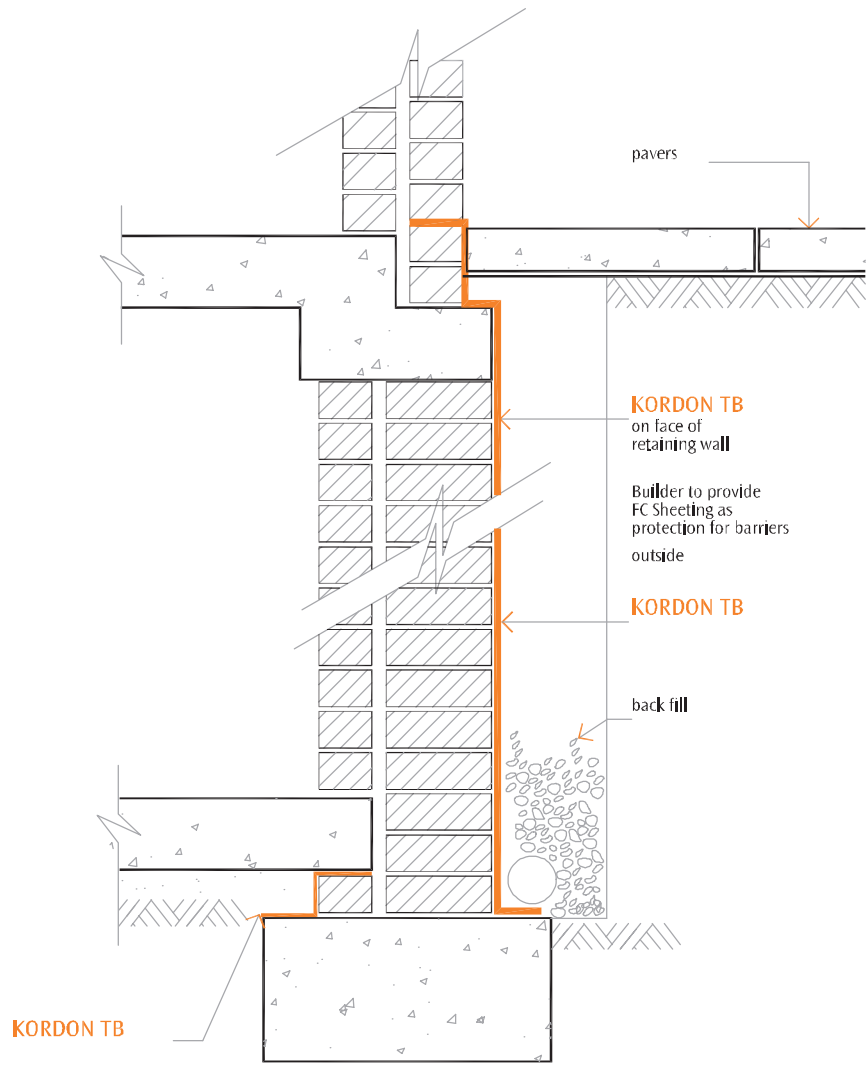
kd 022

retaining wall – detail 2

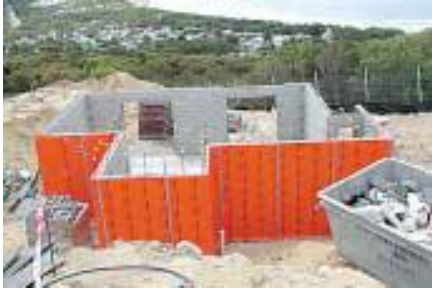
Photo 1  
Kordon TB - full retaining wall

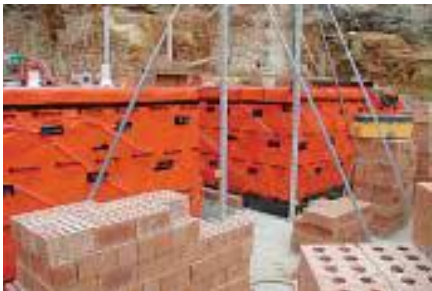
Photo 2  
Kordon TB - retaining/stepdown

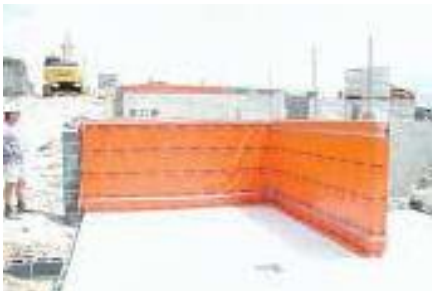
Photo 3  
Kordon TB - internal wall treated

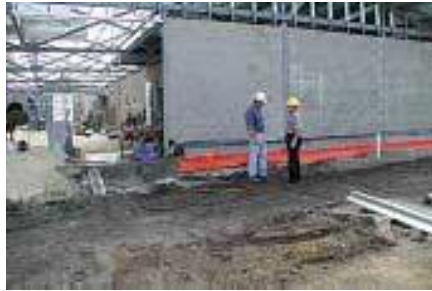
Photo 1  
Kordon TB -commercial building

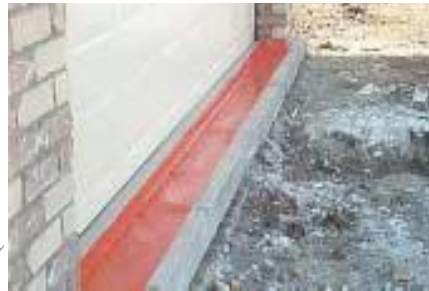
**photo 1**  
garage entry detail  
secured with the aid of 3M "super 77" spray or similar  
Note:  
where various slab conditions prevail i.e. rough or damaged:-  
It is important to establish a full seal to the perimeter is achieved

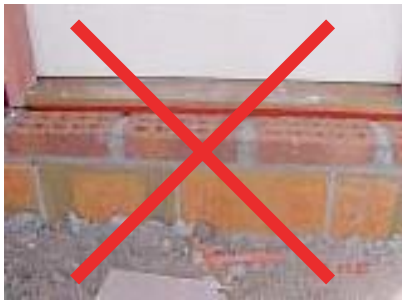
1. incorrect Kordon TB installation. Refer kd 001 and product design principle

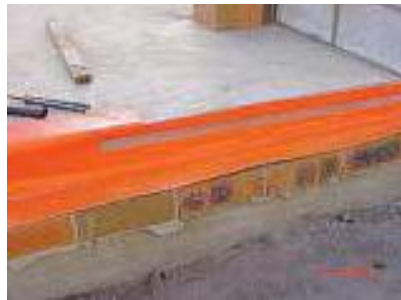
4. if tiling is to extend to slab edge Kordon TB is installed as shown - secured with gal hoop-iron/strapping.

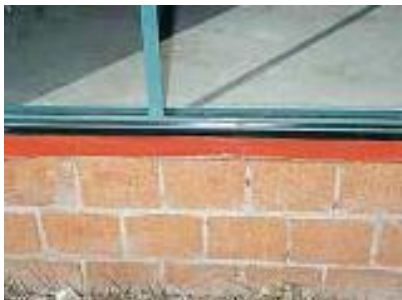
2. renderlok secured to masonry with approved concrete nails. - (15mm length preferred)

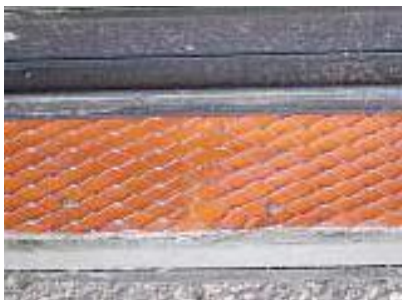
3. close up of 5.

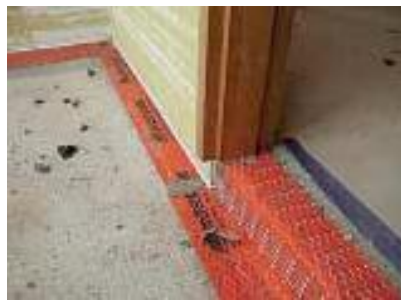
6. renderlok secured to horizontal & vertical to accommodate tiling specification
